Annual Report 2018

Port State Inspections

INDIAN REGISTER OF SHIPPING

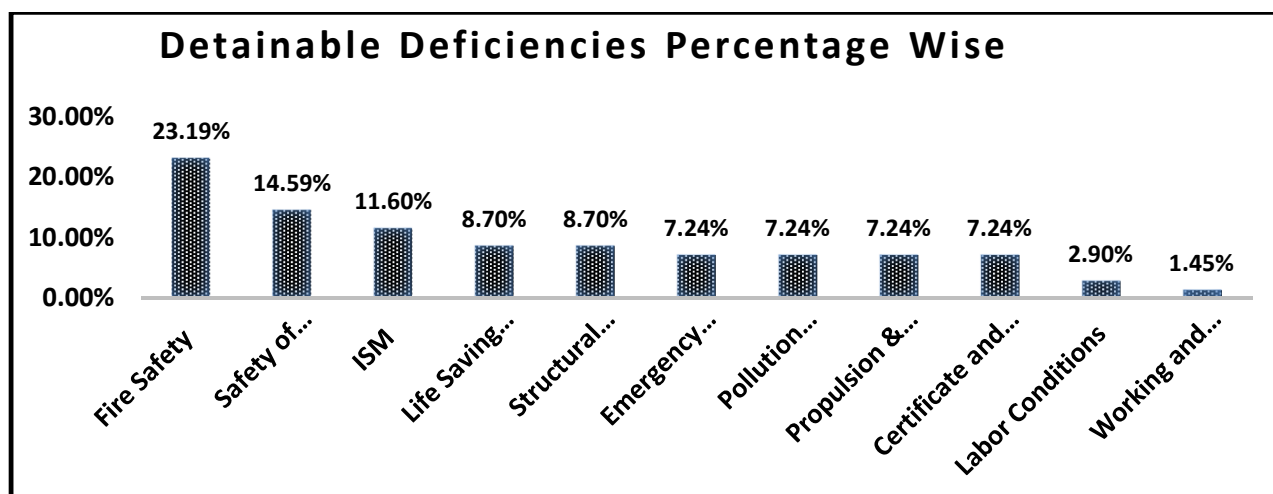
From the list of detainable deficiencies, following is inferred:

- i. Maximum number of detainable deficiencies were recorded under “Fire safety” and were related to malfunctioning fire alarm/detection system, defective emergency fire pump/fire lines, fire doors, faulty ventilators for E/R and machinery spaces, CO2 system and fire risk posed due to oil accumulation.

- ii. Deficiencies pertaining to Safety of Navigation were next to deficiencies under fire safety by numbers. Navigational equipment, mainly VDR/S-VDR, Magnetic compass, Gyro were found defective or malfunctioning, nautical publications/charts and voyage plan found not updated or missing.

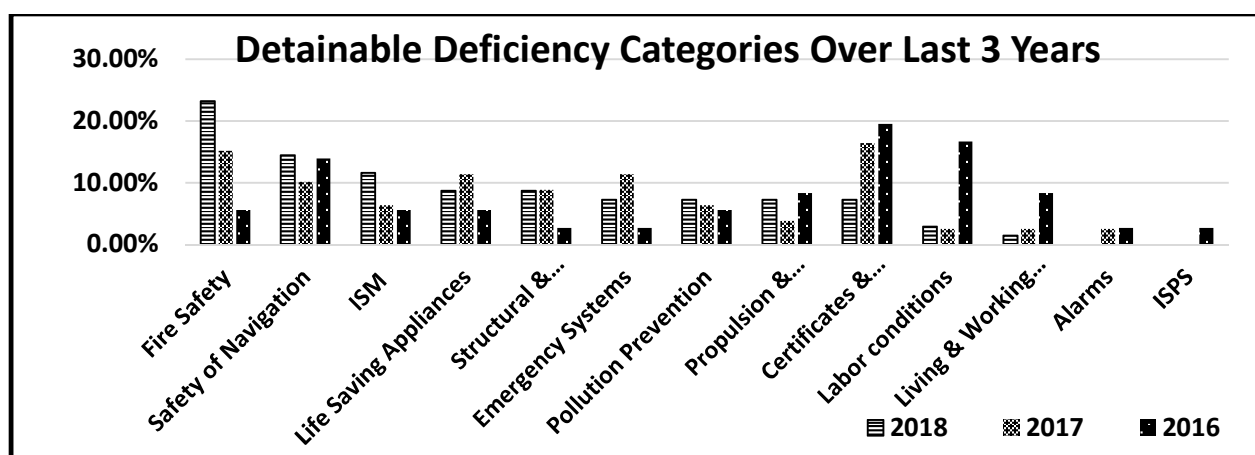
COMPARISON OF DETAINABLE DEFICIENCIES OVER LAST 3 YEARS

From above data it is evident that percentage of detainable deficiencies in areas related to Fire safety, Safety of navigation, ISM, Pollution prevention and Propulsion/Auxiliary machinery increased in 2018 compared to year 2017.

Deficiencies related to Life saving appliances, Emergency Systems, Certificate and documentation, Living and working conditions and compliance to ISPS requirements decreased in year 2018 compared to previous year.

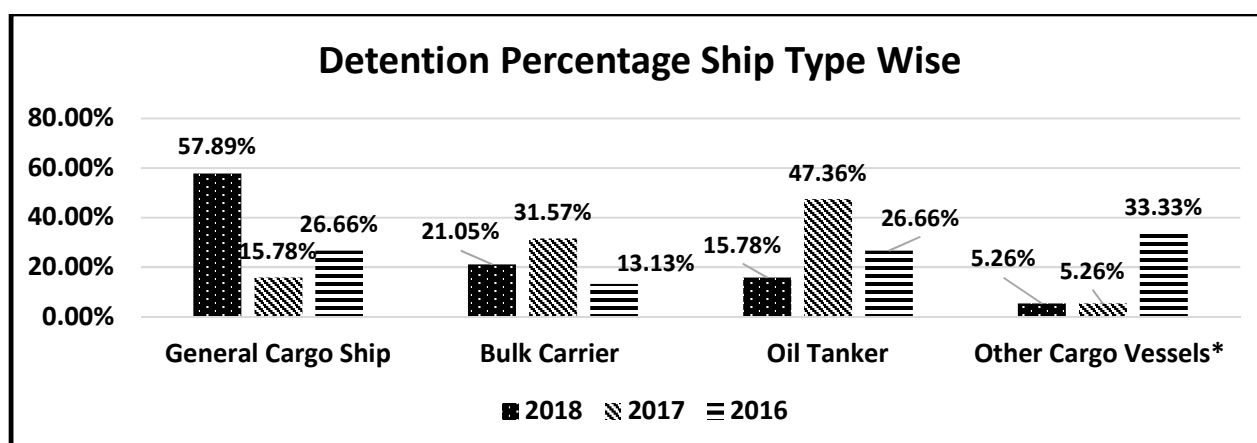
Considering ship type wise, number of General cargo vessels detained were the maximum in year 2018 compared to previous two years i.e. 2017 and 2016. Detention of these vessels were mostly under Paris, Black sea and Mediterranean MoU.

On contrary detentions of Bulk Carriers, Oil tankers and Other Cargo Vessels decreased compared to previous years.

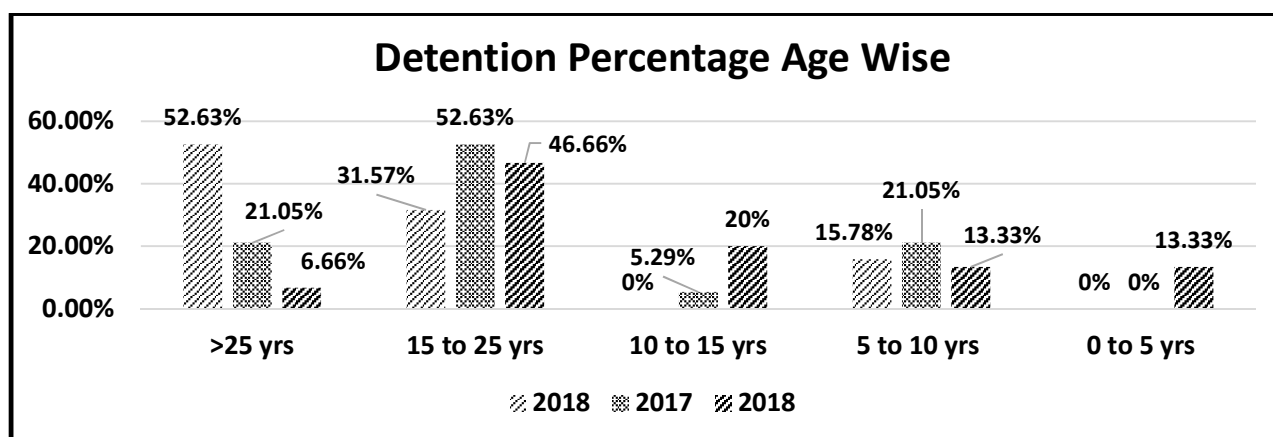
From age wise comparison of detentions in last 3 years, detentions of vessels of higher age group showed rising trend over years with significant increase in number of detentions for age group above 25 years.
